CLEARVIEW  
TOWNSHIP

# Wastewater Collection System 2023 Annual Performance Report

Period Covering: January 1 to December 31, 2023

(Prepared in accordance with CLI-ECA 099-W601, Schedule E)

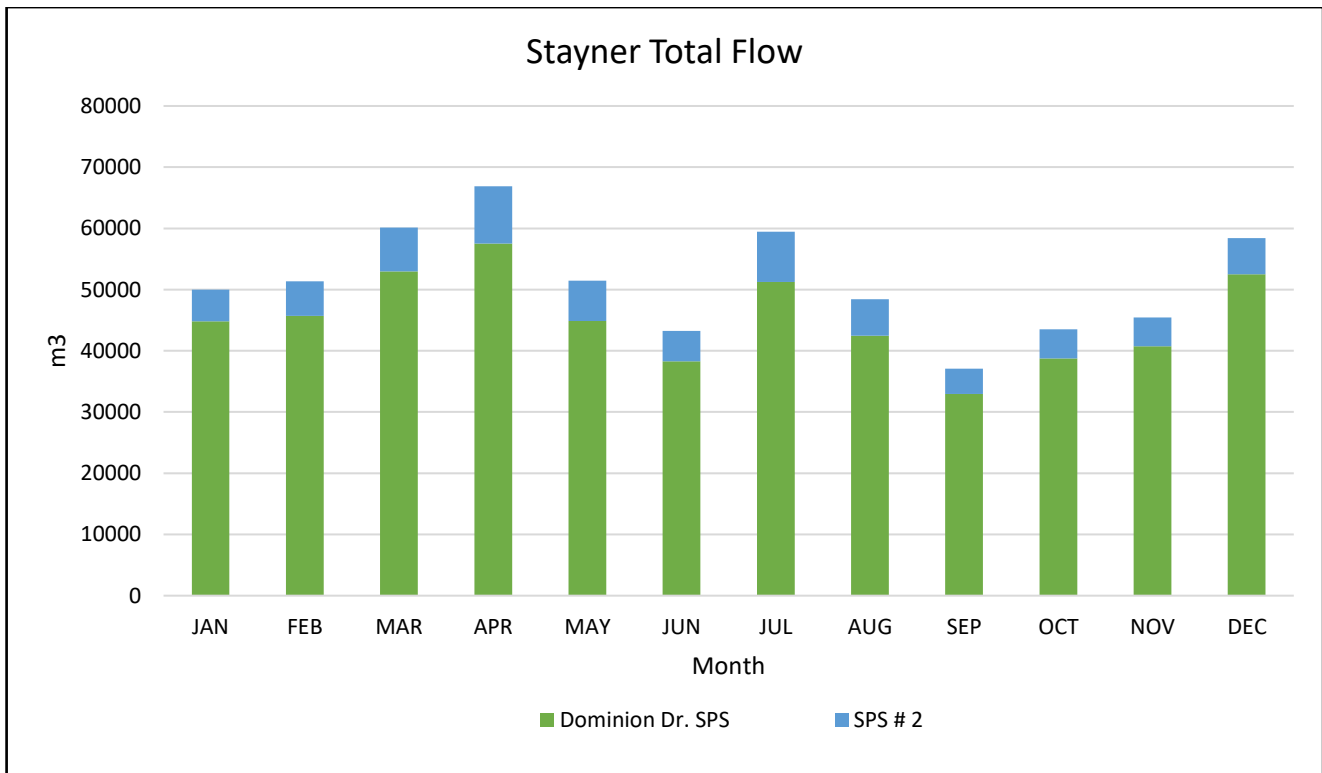
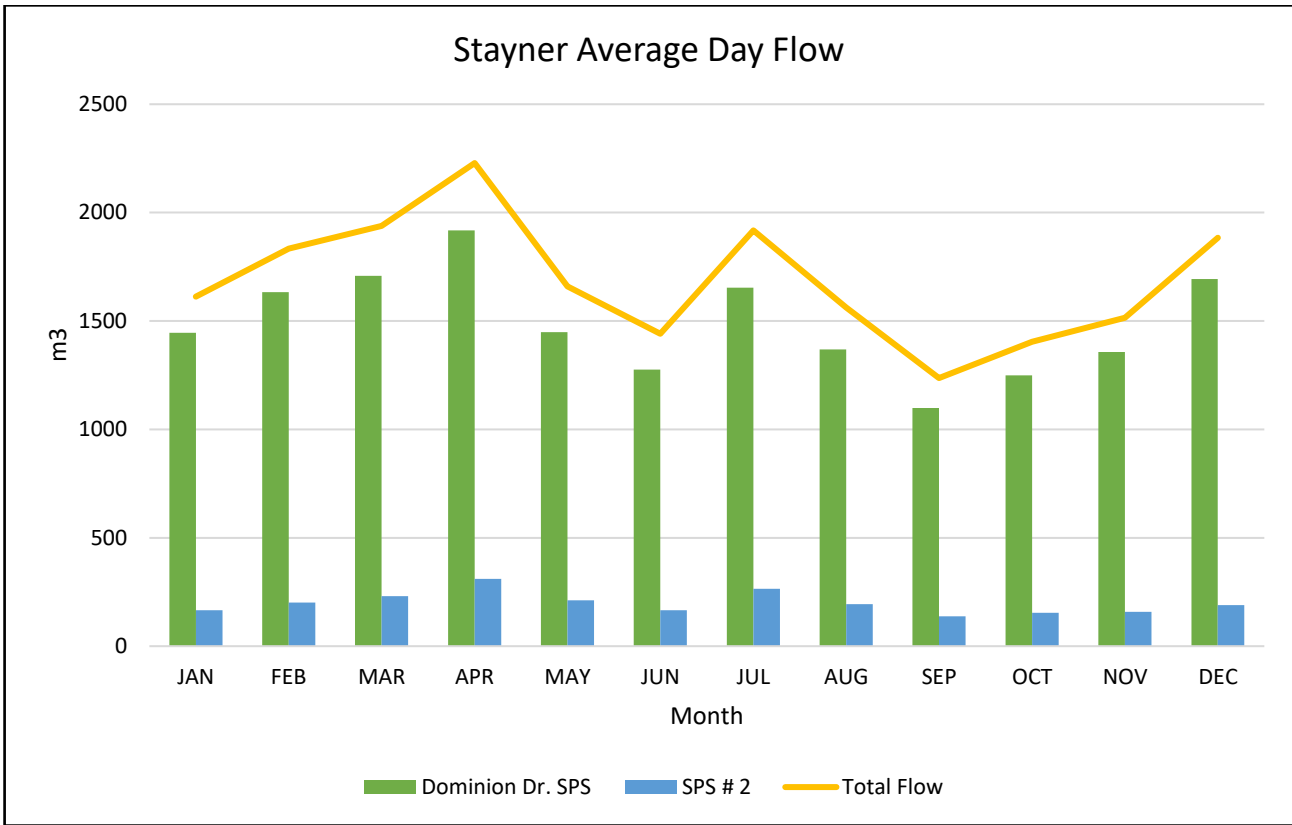
STAYNER	Dominion Dr. SPS			SPS # 2			Stayner Total Flow		
	Total Flow m <sup>3</sup>	Average Day Flow m <sup>3</sup>	Maximum Day Flow m <sup>3</sup>	Total Flow m <sup>3</sup>	Average Day Flow m <sup>3</sup>	Maximum Day Flow m <sup>3</sup>	Total Flow m <sup>3</sup>	Average Day Flow m <sup>3</sup>	Maximum Day Flow m <sup>3</sup>
JAN	44832	1446	1959	5143	166	194	49975	1612	2146
FEB	45714	1633	2281	5631	201	279	51345	1834	2516
MAR	52954	1708	2456	7162	231	355	60116	1939	2811
APR	57533	1918	3037	9326	311	454	66859	2229	3443
MAY	44894	1448	1888	6569	212	307	51463	1660	2195
JUN	38286	1276	1890	4966	166	263	43252	1442	2136
JUL	51273	1654	3492	8186	264	567	59459	1918	4059
AUG	42445	1369	1712	6006	194	260	48451	1563	1971
SEP	32966	1099	1258	4138	138	163	37104	1237	1387
OCT	38732	1249	2213	4797	155	226	43529	1404	2423
NOV	40724	1357	1600	4735	158	191	45459	1515	1756
DEC	52526	1694	2391	5871	189	280	58397	1884	2668

<b>Total/Yr.</b>	<b>542879</b>	<b>1488</b>	<b>3492</b>	<b>72530</b>	<b>199</b>	<b>567</b>	<b>615409</b>	<b>1686</b>	<b>4059</b>

Flows within the collection system were considered normal in 2023. The typical increase in monthly flows during the spring thaw and months with higher precipitation is noted in the flow monitoring data. Annual flows for both the Stayner and Creemore collection areas were in line with the 5-year

average annual flow totals. The collection system appears to be well equipped to handle the currently flow volumes. As more development occurs in Stayner, there will be an increase in the volume of flow directed to SPS # 2. At some point in the future, it will be necessary to begin utilizing the forcemains from this station to the Town of Wasaga Beach and sending them some of the collected wastewater for treatment.

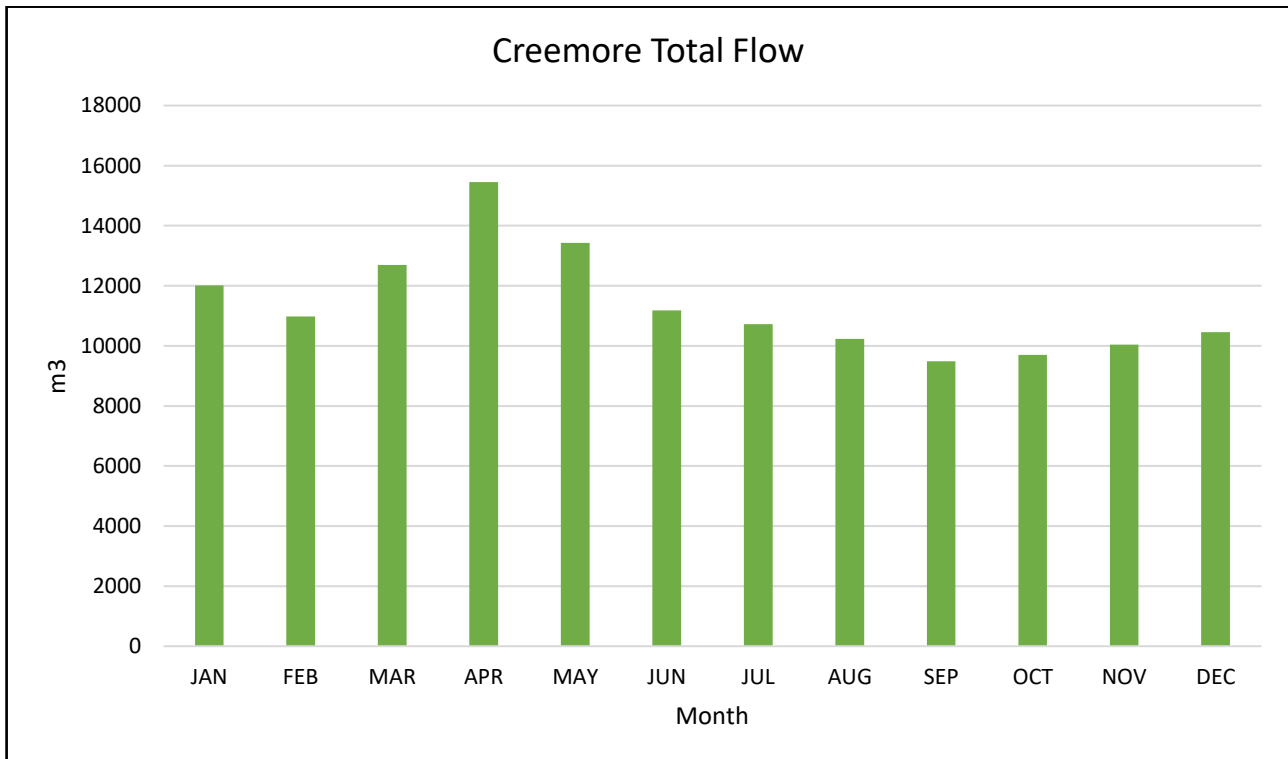
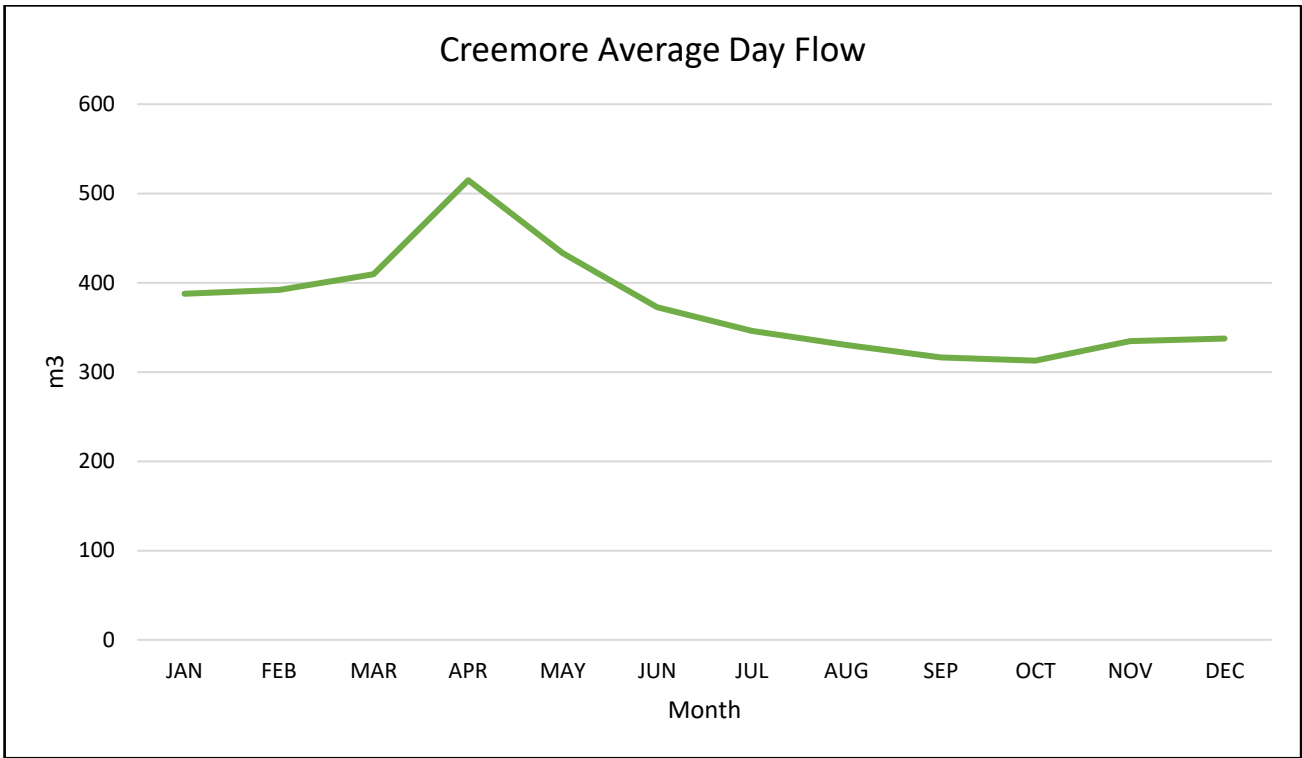
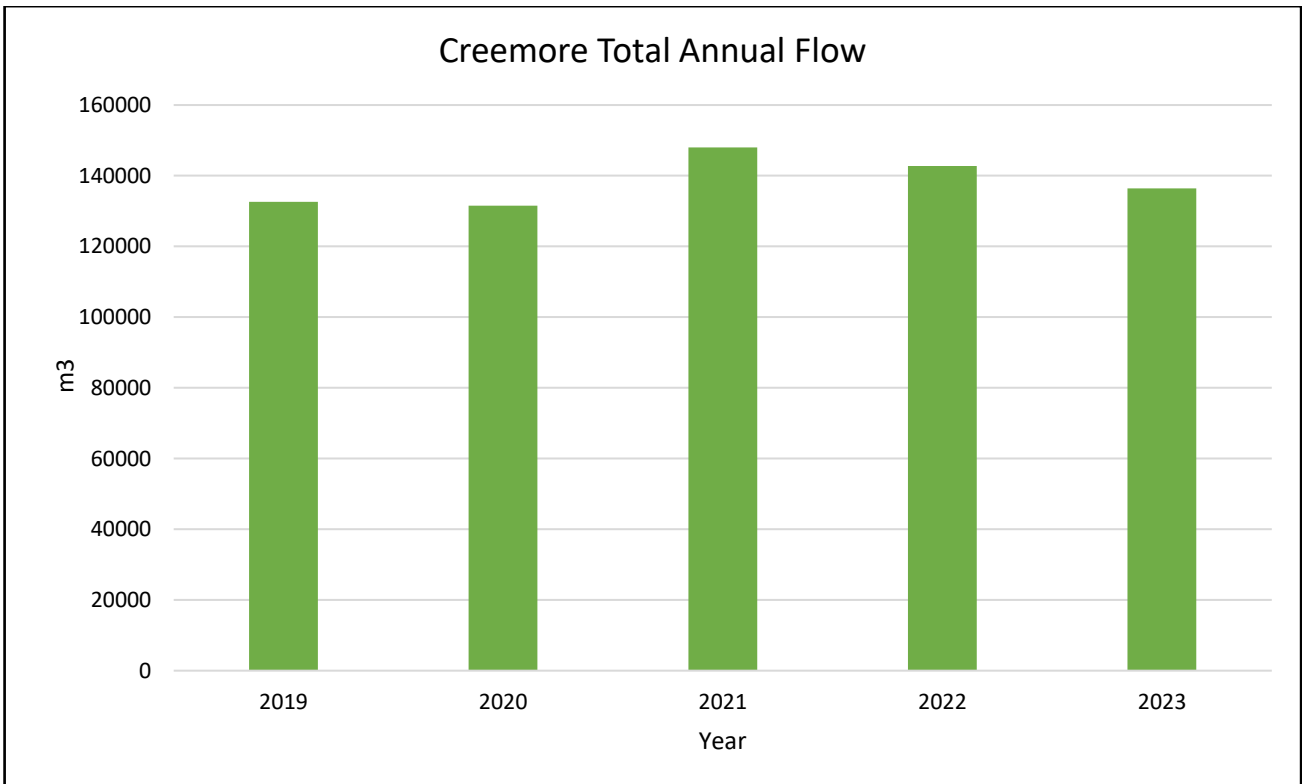
CREEMORE	Creemore WWTP Influent		
	Total Flow m <sup>3</sup>	Average Day Flow m <sup>3</sup>	Maximum Day Flow m <sup>3</sup>
JAN	12016	388	487
FEB	10979	392	456
MAR	12698	410	611
APR	15447	515	619
MAY	13429	433	499
JUN	11175	373	486
JUL	10725	346	442
AUG	10237	330	420
SEP	9486	316	368
OCT	9695	313	365
NOV	10042	335	387
DEC	10459	337	513
<b>Total/Yr.</b>	<b>136388</b>	<b>374</b>	<b>619</b>
